**Flood Control Project Maintenance
Levee Inspections**

Maintenance Issue Types Only, Levee Inspection Report By Mile - Fall 2019

Reclamation District No. 0551 Pearson

Waterway	Bank	Unit Miles	Inspection Start/End	Inspector
Unit No. 01 Sacramento River	Left	6.78	10/22/2019 10/22/2019	David Julian

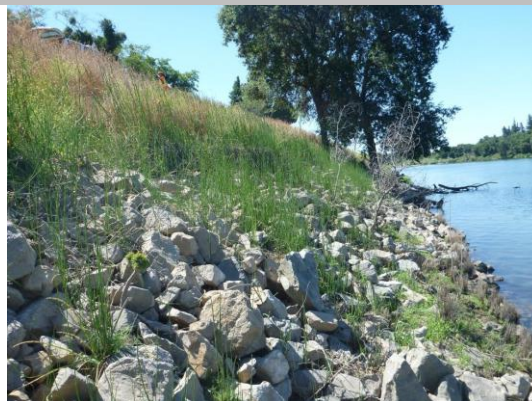
Photo 1 of 3 : FA_2019_RD0551_175_18_20190826_00002.jpg

LM Start	1.61	Rating **	M	Issue No.	18
LM End	1.68	Issue Type +	Ma	Location *	WS
Category	Supplemental		GPS Latitude/Longitude		
			Start	End	
Item	2017 Storm Damage		38.315922 °	38.314978 °	
			-121.576864 °	-121.576936 °	
DWR ID	LMA-158

Comment Code					
Inspector Comment					
<p>Levee Evaluation Comments</p> <p>Description: District Station 84+15 to 87+60, Sec. 06, T. 5 N. R. 4 E., M.D.M. Approximately 135 linear-feet of erosion/sloughing exists along the waterside levee slope of the Sacramento River. Sloughing commences approximately 3/4 of the way down the slope from the crown and extends into the rip rap. Some existing rip rap has been pulled off in this section.</p> <p>Site ID No: 331</p> <p>Site Designation: LMA-158</p> <p>Repair Type: Erosion</p> <p>Rating: Area of Concern</p> <p>Field Date: 7/13/2017</p> <p>Notes: thorny veg on upper slope, light veg within rip rap. Crown is a paved road. 1 ft vertical scarp max just above rip rap so we rated it as a lower priority.</p>

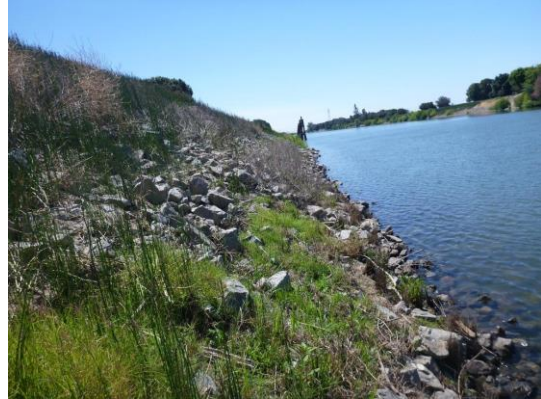
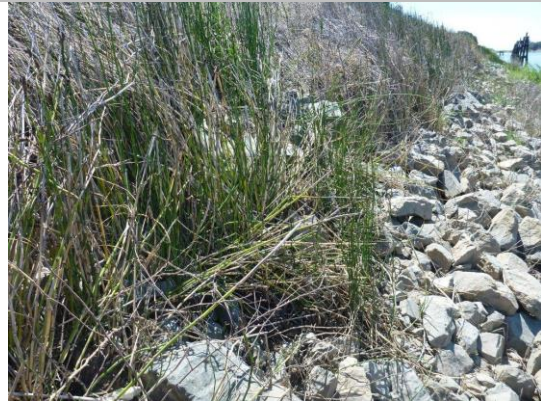
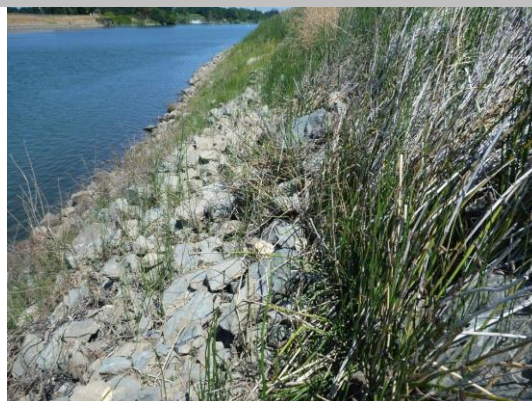
LM Start	2.71	Rating **	A/W	Issue No.	22
LM End	2.74	Issue Type +	Ma	Location *	WS
Category	Supplemental			GPS Latitude/Longitude	
				Start	End
Item	2017 Storm Damage			38.301258 °	38.300922 °
				-121.569550 °	-121.569258 °
DWR ID	LMA-159				
Comment Code					
Inspector Comment					
Levee Evaluation Comments					
Description:District Station 142+31 to 143+80, Sec. 08, T. 5 N. R. 4 E., M.D.M. Approximately 149 linear-feet of erosion exists along the waterside slope of the Sacramento River. The erosion exists near the rip rap line about 3/4 of the way down the slope. Some existing rip rap has been pulled off in this section.					
Site ID No:332					
Site Designation:LMA-159					
Repair Type: Erosion					
Rating:Area of Concern					
Field Date:7/13/2017					
Notes: Crown is a paved road. Minor errosion right above and in the top of the rip rap.

Item	2017 Storm Damage		38.301258 °	38.300922 °								
			-121.569550 °	-121.569258 °								
DWR ID	LMA-159											
Comment Code												
Inspector Comment												
<p>Levee Evaluation Comments</p> <p>Description: District Station 142+31 to 143+80, Sec. 08, T. 5 N. R. 4 E., M.D.M. Approximately 149 linear-feet of erosion exists along the waterside slope of the Sacramento River. The erosion exists near the rip rap line about 3/4 of the way down the slope. Some existing rip rap has been pulled off in this section.</p> <p>Site ID No: 332</p> <p>Site Designation: LMA-159</p> <p>Repair Type: Erosion</p> <p>Rating: Area of Concern</p> <p>Field Date: 7/13/2017</p> <p>Notes: Crown is a paved road. Minor erosion right above and in the top of the rip rap.</p>

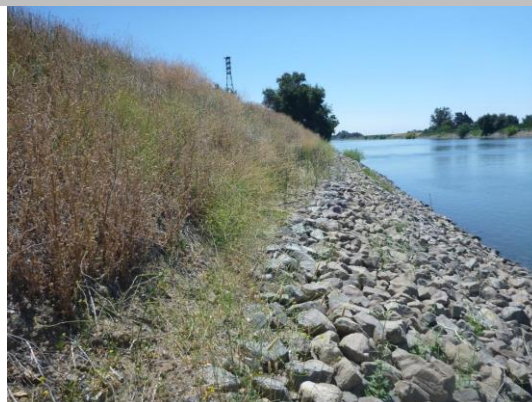
Photo 1 of 3 : FA_2019_RD0551_175_26_20190826_00014.jpg

LM Start	3.04	Rating **	A/W	Issue No.	26							
LM End	3.25	Issue Type +	Ma	Location *	WS							
Category	Supplemental		GPS Latitude/Longitude									
			Start	End

Item	2017 Storm Damage		38.297258 °	38.294806 °								
			-121.566231 °	-121.563958 °								
DWR ID	LMA-160											
Comment Code												
Inspector Comment												
<p>Levee Evaluation Comments</p> <p>Description: District Station 159+69 to 170+73, Sec. 08, T. 5 N. R. 4 E., M.D.M. Approximately 1,104 linear-feet of erosion and subsequent sloughing exists along the waterside slope of the Sacramento River. The erosion commences approximately halfway down the slope to the rip rap line.</p> <p>Site ID No: 333</p> <p>Site Designation: LMA-160</p> <p>Repair Type: Erosion</p> <p>Rating: Area of Concern</p> <p>Field Date: 7/13/2017</p> <p>Notes: Crown is a paved road. Thorny veg on upper slope, none in rip rap. Scarps up to 3 ft, mostly smaller, above rip rap. Area of concern because erosion is not too deep into prism and good rip rap protection on lower slope.</p>

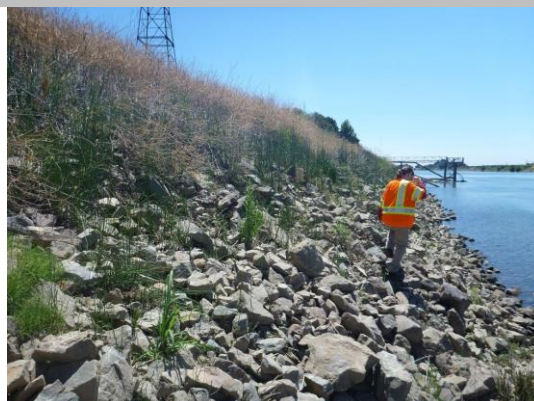
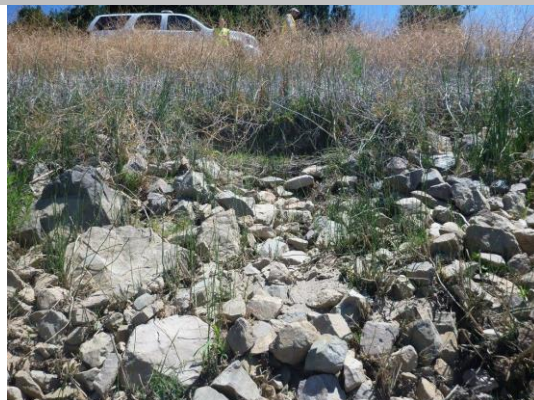
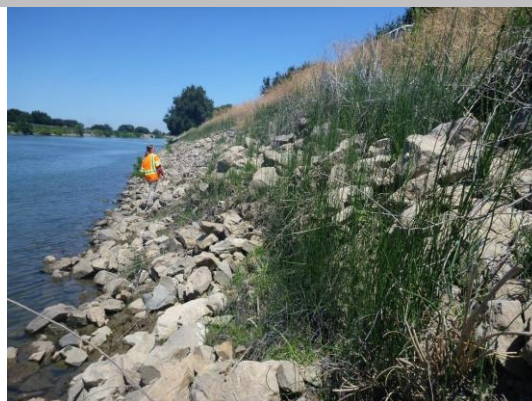
LM Start	3.34	Rating **	M	Issue No.	27
LM End	3.36	Issue Type +	Ma	Location *	WS
Category	Supplemental			GPS Latitude/Longitude	
				Start	End
Item	2017 Storm Damage			38.293842 °	38.293642 °
				-121.562917 °	-121.562708 °
DWR ID	LMA-161

Comment Code					
Inspector Comment					
Levee Evaluation Comments					
Description:District Station 175+36 to 176+30, Sec. 08, T. 5 N. R. 4 E., M.D.M. Approximately 94 linear-feet of erosion exists along the waterside slope of the Sacramento River. The erosion occurs within the rip rap area near the waterline. Sloughing is exhibited in the in the bottom half of the slope. Some existing rip rap has been pulled off in this section.					
Site ID No:334					
Site Designation:LMA-161					
Repair Type: Erosion					
Rating:Area of Concern					
Field Date:7/13/2017					
Notes: Crown is a paved road. Scarps up to 3 ft within rip rap and 18 in above rip rap. Lower priority because erosion does not significantly cut into prism and damage was not continuous through whole site.

Comment Code						
Inspector Comment						
Levee Evaluation Comments						
Description:District Station 175+36 to 176+30, Sec. 08, T. 5 N. R. 4 E., M.D.M. Approximately 94 linear-feet of erosion exists along the waterside slope of the Sacramento River. The erosion occurs within the rip rap area near the waterline. Sloughing is exhibited in the in the bottom half of the slope. Some existing rip rap has been pulled off in this section.						
Site ID No:334						
Site Designation:LMA-161						
Repair Type: Erosion						
Rating:Area of Concern						
Field Date:7/13/2017						
Notes: Crown is a paved road. Scarps up to 3 ft within rip rap and 18 in above rip rap. Lower priority because erosion does not significantly cut into prism and damage was not continuous through whole site.

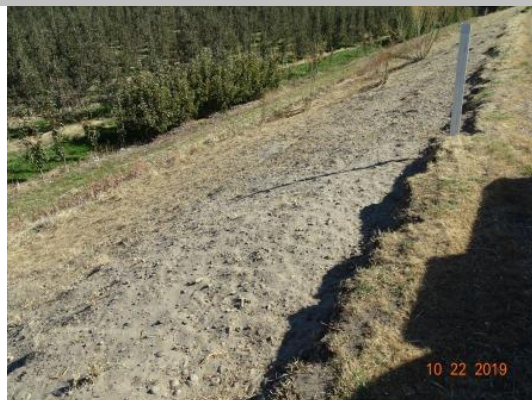
Photo 1 of 1 : FA_2019_RD0551_175_66_20191024_00123.jpg

LM Start	3.91	Rating **	M	Issue No.	66
LM End	3.91	Issue Type +	Ma	Location *	LS
Category	Earthen Levee			GPS Latitude/Longitude	
				Start	End
Item	Erosion / Bank Caving			38.287760 °	38.287760 °
				-121.555837 °	-121.555837 °
DWR ID	DWR_RD0551_01_f_2019_66				
Comment Code					
E2 : Schedule repair of erosion site prior to the next inspection.					
Inspector Comment

View looking downstream at erosion due to goats on the landside slope (Fall 2019).

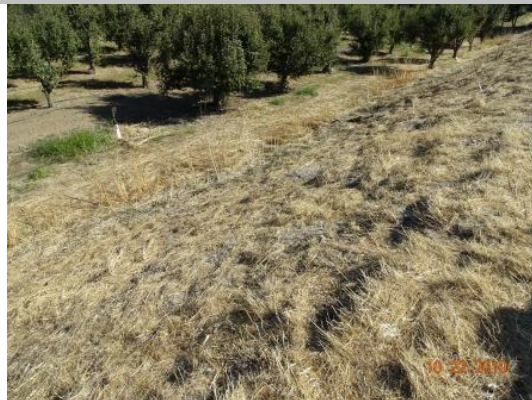
Photo 1 of 1 : FA_2019_RD0551_175_53_20191024_00122.jpg

View looking downstream at fresh rodent holes in the landside slope (Fall 2019).

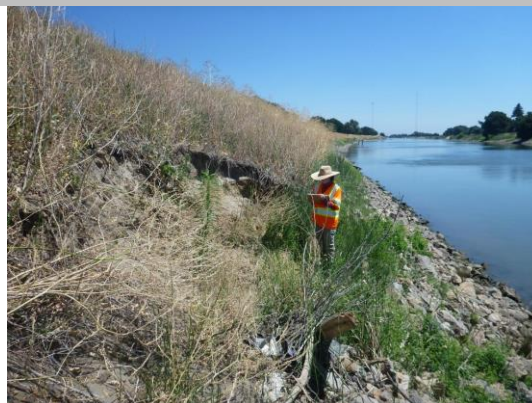
Photo 1 of 3 : FA_2019_RD0551_175_28_20190826_00020.jpg

LM Start	4.39	Rating **	M	Issue No.	28
LM End	4.47	Issue Type +	Ma	Location *	WS
Category	Supplemental			GPS Latitude/Longitude	
				Start	End
Item	2017 Storm Damage			38.282778 °	38.282108 °
				-121.549531 °	-121.548386 °
DWR ID	LMA-163

Comment Code					
Inspector Comment					
Levee Evaluation Comments					
Description:District Station 231+12 to 235+26, Sec. 16, T. 5 N. R. 4 E., M.D.M. Approximately 414 linear-feet of erosion and subsequent sloughing exists along the waterside slope of the Sacramento River. The erosion commences approximately 3/4 of the way down the slope to the rip rap line.					
Site ID No:336					
Site Designation:LMA-163					
Repair Type: Erosion					
Rating:Area of Concern					
Field Date:7/13/2017					
Notes: We only saw erosion on about 1½ the length reported by the LMA, but there is another site very close by. Crown is a paved road. Scarps up to 5 ft deep above the rip rap, mostly smaller though so rated this a lower priority site.

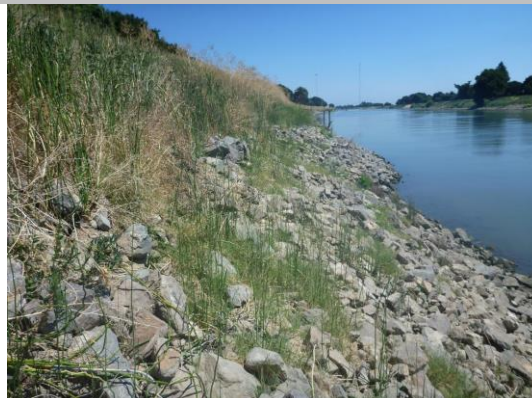
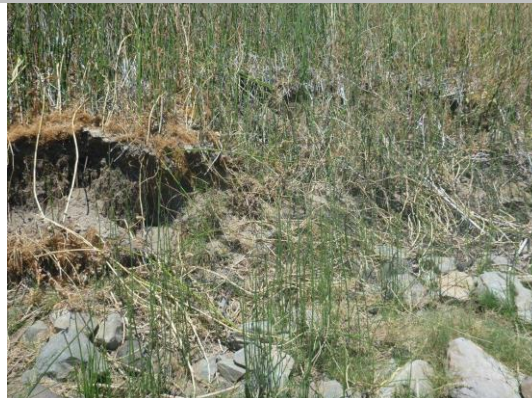
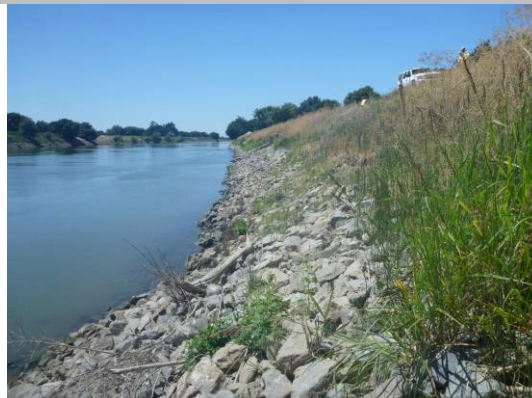
LM Start	4.49	Rating **	A/W	Issue No.	29
LM End	4.52	Issue Type +	Ma	Location *	WS
Category	Supplemental			GPS Latitude/Longitude	
				Start	End
Item	2017 Storm Damage			38.281994 °	38.281653 °
				-121.548214 °	-121.547700 °
DWR ID	LMA-164

Comment Code					
Inspector Comment					
Levee Evaluation Comments					
Description: District Station 235+90 to 237+83, Sec. 16, T. 5 N. R. 4 E., M.D.M. Approximately 193 linear-feet of erosion exists along the waterside slope of the Sacramento River. The erosion commences approximately halfway down the slope and extends to the rip rap. Some existing rip rap has been pulled off in this section.					
Site ID No: 337					
Site Designation: LMA-164					
Repair Type: Erosion					
Rating: Area of Concern					
Field Date: 7/13/2017					
Notes: Crown is paved road. Veg on slope, not lower bank. Scarps up to 18 in deep above rip rap. Lower priority because erosion is fairly small and rip rap is in good shape through most of the site.

Comment Code					
Inspector Comment					
<p>Levee Evaluation Comments</p> <p>Description: District Station 235+90 to 237+83, Sec. 16, T. 5 N. R. 4 E., M.D.M. Approximately 193 linear-feet of erosion exists along the waterside slope of the Sacramento River. The erosion commences approximately halfway down the slope and extends to the rip rap. Some existing rip rap has been pulled off in this section.</p> <p>Site ID No: 337</p> <p>Site Designation: LMA-164</p> <p>Repair Type: Erosion</p> <p>Rating: Area of Concern</p> <p>Field Date: 7/13/2017</p> <p>Notes: Crown is paved road. Veg on slope, not lower bank. Scarps up to 18 in deep above rip rap. Lower priority because erosion is fairly small and rip rap is in good shape through most of the site.</p>

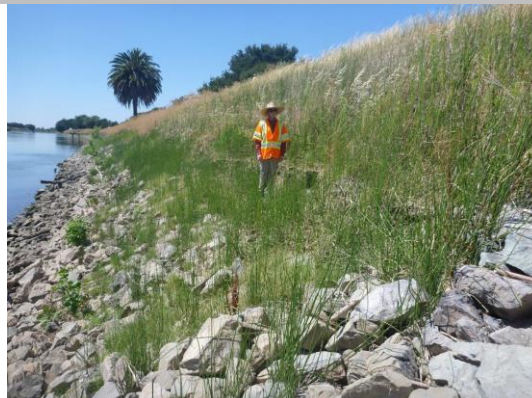
Photo 1 of 3 : FA_2019_RD0551_175_30_20190826_00026.jpg

LM Start	4.67	Rating **	A/W	Issue No.	30
LM End	4.70	Issue Type +	Ma	Location *	WS
Category	Supplemental			GPS Latitude/Longitude	
				Start	End
Item	2017 Storm Damage			38.280236 °	38.279892 °
				-121.545758 °	-121.545314 °
DWR ID	LMA-165

Comment Code					
Inspector Comment					
<p>Levee Evaluation Comments</p> <p>Description: District Station 245+47 to 247+26, Sec. 16, T. 5 N. R. 4 E., M.D.M. Approximately 179 linear-feet of erosion and sloughing exists along the waterside slope of the Sacramento River. The erosion commences approximately halfway down the slope and extends to the rip rap. Some existing rip rap has been pulled off in this section.</p> <p>Site ID No: 338</p> <p>Site Designation: LMA-165</p> <p>Repair Type: Erosion</p> <p>Rating: Area of Concern</p> <p>Field Date: 7/13/2017</p> <p>Notes: Crown is paved road. Scarps up to 7 ft deep, 2 ft typical above the rip rap. Area of concern because the deeper scarp only covered a short distance and was already vegetated so not actively eroding.</p>

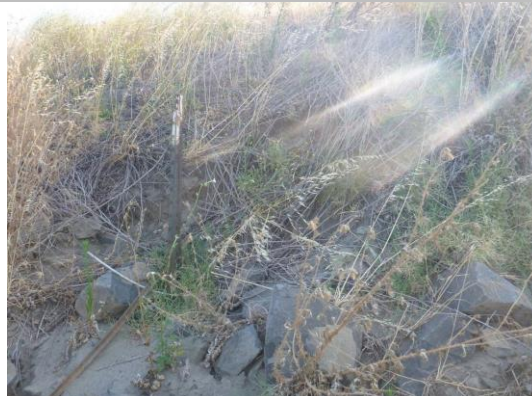
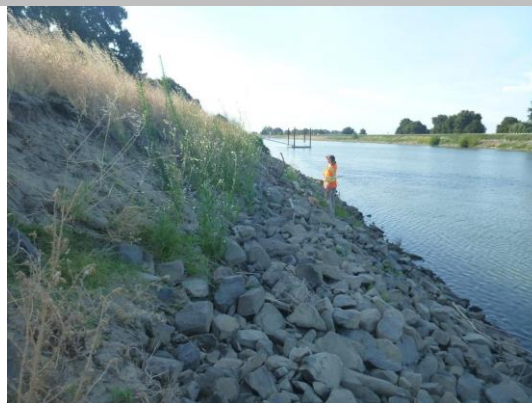
LM Start	4.92	Rating **	A/W	Issue No.	31
LM End	4.95	Issue Type +	Ma	Location *	WS
Category	Supplemental			GPS Latitude/Longitude	
				Start	End
Item	2017 Storm Damage			38.277589 °	38.277256 °
				-121.542575 °	-121.542211 °
DWR ID	LMA-166

Comment Code					
Inspector Comment					
Levee Evaluation Comments					
Description:District Station 258+80 to 260+40, Sec. 16, T. 5 N. R. 4 E., M.D.M. Approximately 160 linear-feet of erosion exists along the waterside slope of the Sacramento River. The erosion commences approximately halfway down the slope from the crown and extends to the rip rap. Some existing rip rap has been pulled off in this section.					
Site ID No:339					
Site Designation:LMA-166					
Repair Type: Erosion					
Rating:Area of Concern					
Field Date:7/14/2017					
Notes: crown is a paved road. Scarps of 2.5 ft just above rip rap. Area of concern because erosion is fairly small.

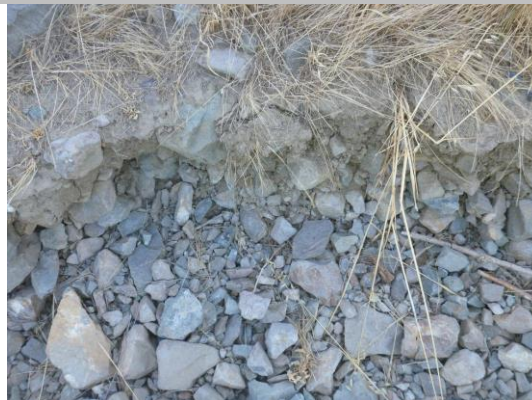
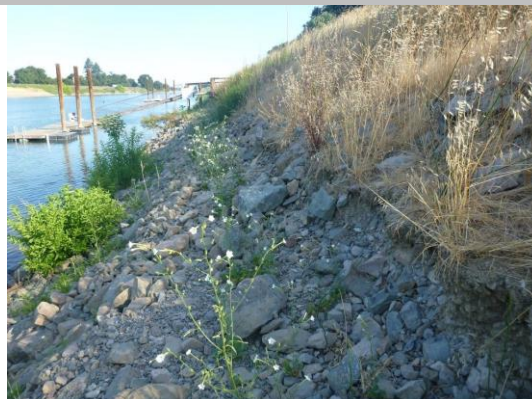
LM Start	5.06	Rating **	A/W	Issue No.	32 (cont)
LM End	5.09	Issue Type +	Ma	Location *	WS
Category	Supplemental			GPS Latitude/Longitude	
				Start	End
Item	2017 Storm Damage			38.276072 °	38.275761 °
				-121.540869 °	-121.540497 °
DWR ID	LMA-167

Repair Type: Erosion

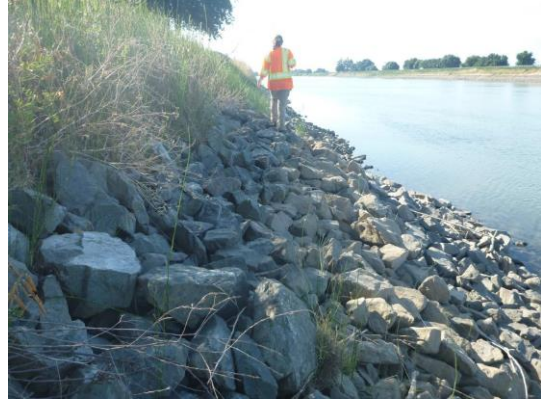
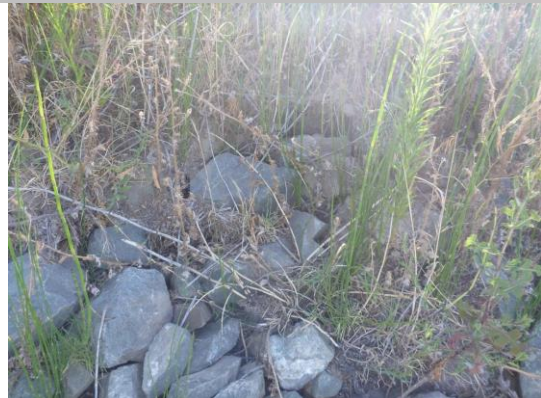
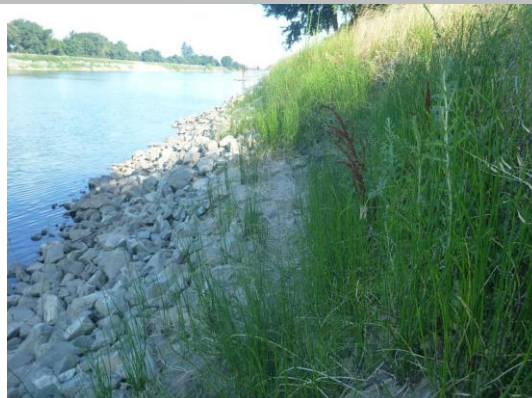
LM Start	5.12	Rating **	A/W	Issue No.	33
LM End	5.16	Issue Type +	Ma	Location *	WS
Category	Supplemental			GPS Latitude/Longitude	
				Start	End
Item	2017 Storm Damage			38.275442°	38.274997°
				-121.540094°	-121.539514°
DWR ID	LMA-168

Comment Code					
Inspector Comment					
Levee Evaluation Comments					
Description:District Station 269+37 to 271+66, Sec. 21, T. 5 N. R. 4 E., M.D.M. Approximately 229 linear-feet of erosion and sloughing exists along the waterside slope of the Sacramento River. The erosion commences approximately 3/4 of the way down the slope from the crown and extends to the rip rap.					
Site ID No:341					
Site Designation:LMA-168					
Repair Type: Erosion					
Rating:Area of Concern					
Field Date:7/14/2017					
Notes: crown is a paved road. Scarps up to 4-5 ft, but 18 inches for most of the length. Large tree within site. Area of concern because deeper erosion is only present for a short distance.

Item	2017 Storm Damage		38.275442°	38.274997°								
			-121.540094°	-121.539514°								
DWR ID	LMA-168											
Comment Code												
Inspector Comment												
<p>Levee Evaluation Comments</p> <p>Description: District Station 269+37 to 271+66, Sec. 21, T. 5 N. R. 4 E., M.D.M. Approximately 229 linear-feet of erosion and sloughing exists along the waterside slope of the Sacramento River. The erosion commences approximately 3/4 of the way down the slope from the crown and extends to the rip rap.</p> <p>Site ID No: 341</p> <p>Site Designation: LMA-168</p> <p>Repair Type: Erosion</p> <p>Rating: Area of Concern</p> <p>Field Date: 7/14/2017</p> <p>Notes: crown is a paved road. Scarps up to 4-5 ft, but 18 inches for most of the length. Large tree within site. Area of concern because deeper erosion is only present for a short distance.</p>

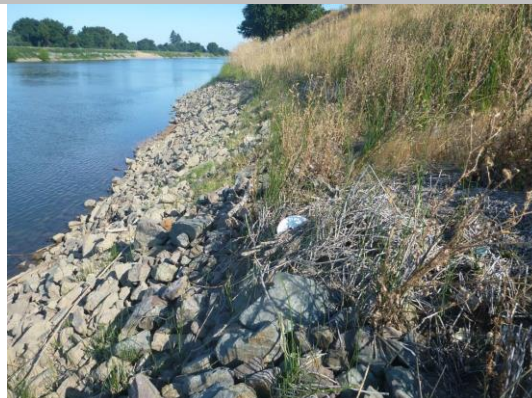
Photo 1 of 3 : FA_2019_RD0551_175_34_20190826_00038.jpg

LM Start	5.20	Rating **	A/W	Issue No.	34							
LM End	5.28	Issue Type +	Ma	Location *	WS							
Category	Supplemental		GPS Latitude/Longitude									
			Start	End

Item	2017 Storm Damage		38.274592°	38.273800°								
			-121.538958°	-121.537869°								
DWR ID	LMA-169											
Comment Code												
Inspector Comment												
<p>Levee Evaluation Comments</p> <p>Description: District Station 273+82 to 278+08, Sec. 21 and 22, T. 5 N. R. 4 E., M.D.M. Approximately 426 linear-feet of erosion exists along the waterside slope of the Sacramento River. The erosion commences approximately halfway down the slope and extends to the rip rap. Some existing rip rap has been pulled off in this section.</p> <p>Site ID No: 342</p> <p>Site Designation: LMA-169</p> <p>Repair Type: Erosion</p> <p>Rating: Serious</p> <p>Field Date: 7/14/2017</p> <p>Notes: there is a 7 ft scarp that extends for 40-60 ft in very sandy soil, scarps are 2-4 ft the rest of the length. Worst site in this RD so far. Serious because of the length of this deeper scarp and the weak soil here. Crown is a paved road.</p>

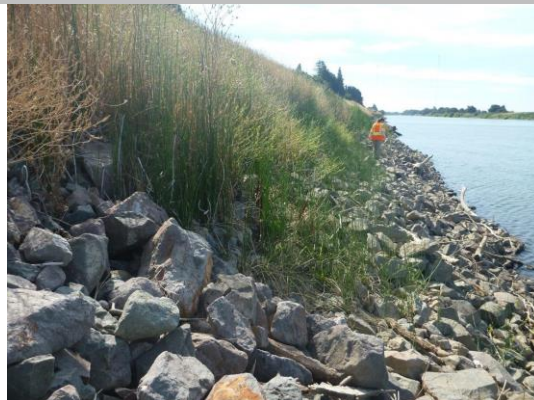
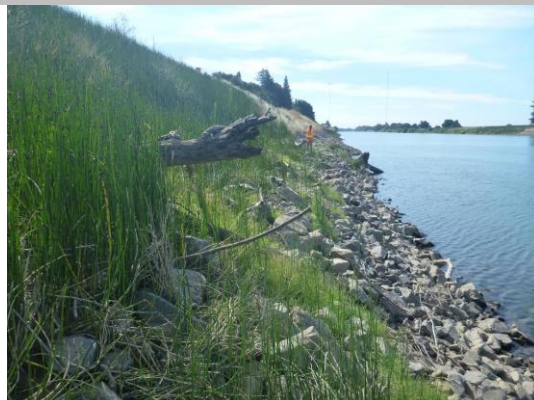
LM Start	5.38	Rating **	A/W	Issue No.	35
LM End	5.42	Issue Type +	Ma	Location *	WS
Category	Supplemental			GPS Latitude/Longitude	
				Start	End
Item	2017 Storm Damage			38.272867 °	38.272411 °
				-121.536597 °	-121.535983 °
DWR ID	LMA-170

Comment Code					
Inspector Comment					
Levee Evaluation Comments					
Description:District Station 283+08 to 285+49, Sec. 22, T. 5 N. R. 4 E., M.D.M. Approximately 241 linear-feet of erosion and sloughing exists along the waterside slope of the Sacramento River. The erosion commences approximately 3/4 of the way down the slope and extends to the rip rap. Some existing rip rap has been pulled off in this section. Site ID No:343					
Site Designation:LMA-170					
Repair Type: Erosion					
Rating:Area of Concern					
Field Date:7/14/2017					
Notes: Crown is a paved road. Scarps above rip rap 2-4 ft deep, but not continuous through whole site. Area of concern because erosion is not very deep into prism and is not continuous throughout site.

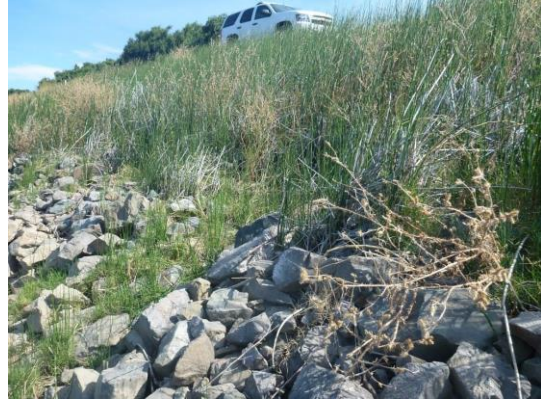
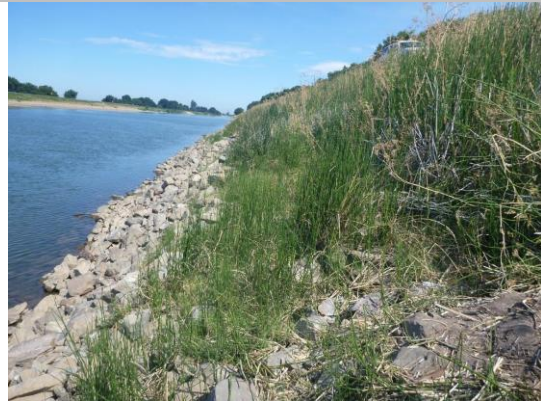
Item	2017 Storm Damage			38.271406°	38.271208°	
				-121.534644°	-121.534381°	
DWR ID	LMA-171					
Comment Code						
Inspector Comment						
Levee Evaluation Comments						
Description: District Station 290+80 to 291+85, Sec. 22, T. 5 N. R. 4 E., M.D.M. Approximately 105 linear-feet of erosion and sloughing exists along the waterside slope of the Sacramento River. The erosion commences approximately 3/4 of the way down the slope and extends into the rip rap. Some existing rip rap has been pulled off in this section.						
Site ID No: 344						
Site Designation: LMA-171						
Repair Type: Erosion						
Rating: Area of Concern						
Field Date: 7/14/2017						
Notes: Crown is a paved road. Erosion scarps 1-4 ft deep just above rip rap. Area of concern because erosion is not very deep into prism.

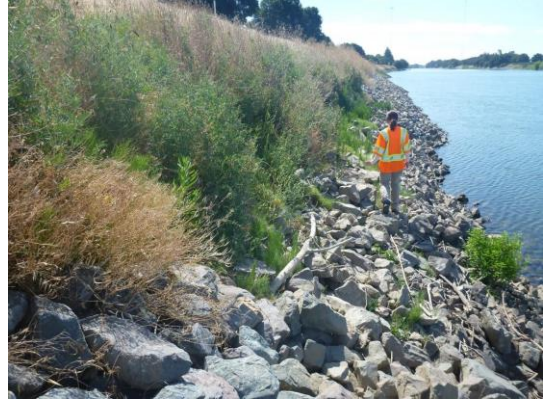
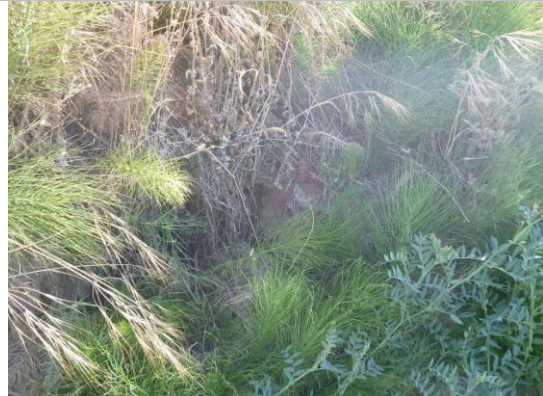
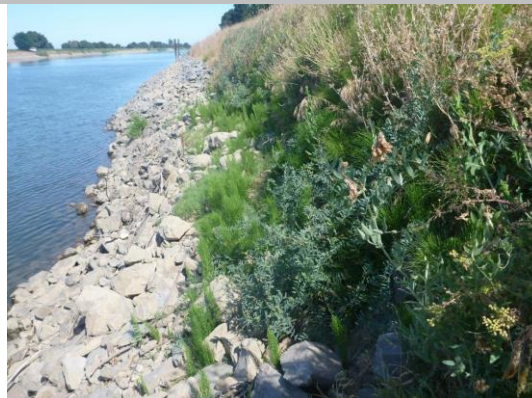
LM Start	5.77	Rating **	A/W	Issue No.	37
LM End	5.79	Issue Type +	Ma	Location *	WS
Category	Supplemental			GPS Latitude/Longitude	
				Start	End
Item	2017 Storm Damage			38.269025 °	38.268814 °
				-121.531361 °	-121.531058 °
DWR ID	LMA-172

Comment Code					
Inspector Comment					
Levee Evaluation Comments					
Description:District Station 303+60 to 304+75, Sec. 22, T. 5 N. R. 4 E., M.D.M. Approximately 115 linear-feet of erosion and sloughing exists along the waterside slope of the Sacramento River. The erosion occurs just above the rip rap line. Some existing rip rap has been pulled off in this section.					
Site ID No:345					
Site Designation:LMA-172					
Repair Type: Erosion					
Rating:Area of Concern					
Field Date:7/14/2017					
Notes: Crown is a paved road. 4 ft deep scarp above the rip rap. Area of concern because erosion is not very deep into prism and there was lots of vegetation growing in the damaged area indicating it may be an older issue.

Item	2017 Storm Damage		38.269025 °	38.268814 °								
			-121.531361 °	-121.531058 °								
DWR ID	LMA-172											
Comment Code												
Inspector Comment												
<p>Levee Evaluation Comments</p> <p>Description: District Station 303+60 to 304+75, Sec. 22, T. 5 N. R. 4 E., M.D.M. Approximately 115 linear-feet of erosion and sloughing exists along the waterside slope of the Sacramento River. The erosion occurs just above the rip rap line. Some existing rip rap has been pulled off in this section.</p> <p>Site ID No: 345</p> <p>Site Designation: LMA-172</p> <p>Repair Type: Erosion</p> <p>Rating: Area of Concern</p> <p>Field Date: 7/14/2017</p> <p>Notes: Crown is a paved road. 4 ft deep scarp above the rip rap. Area of concern because erosion is not very deep into prism and there was lots of vegetation growing in the damaged area indicating it may be an older issue.</p>

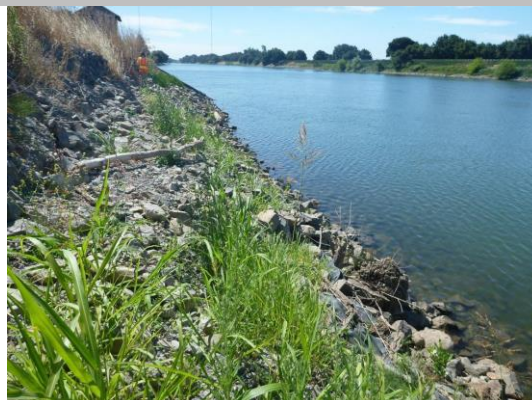
Photo 1 of 3 : FA_2019_RD0551_175_38_20190826_00050.jpg

LM Start	5.85	Rating **	M	Issue No.	38							
LM End	5.86	Issue Type +	Ma	Location *	WS							
Category	Supplemental		GPS Latitude/Longitude									
			Start	End

Item	2017 Storm Damage		38.268244 °	38.268139 °								
			-121.530233 °	-121.530075 °								
DWR ID	LMA-173											
Comment Code												
Inspector Comment												
<p>Levee Evaluation Comments</p> <p>Description: District Station 307+90 to 305+49, Sec. 22, T. 5 N. R. 4 E., M.D.M. Approximately 59 linear-feet of erosion exists along the waterside slope of the Sacramento River. The erosion occurs approximately halfway down the slope within the rip rapped area. Existing rip rap has been pulled off in this section.</p> <p>Site ID No: 346</p> <p>Site Designation: LMA-173</p> <p>Repair Type: Erosion</p> <p>Rating: Area of Concern</p> <p>Field Date: 7/14/2017</p> <p>Notes: Crown is a paved road. Erosion scarps 4-6 ft high, but soil is more stable than other nearby sites with large gravel in silt or clay so we rated this as an area of concern.</p>

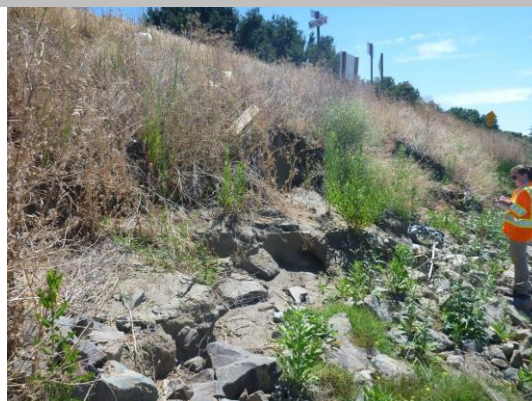
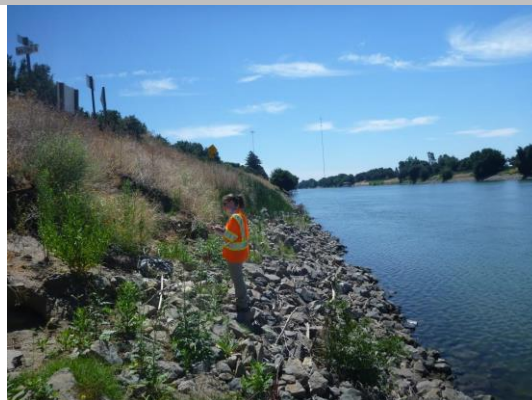
LM Start	6.01	Rating **	M	Issue No.	41
LM End	6.08	Issue Type +	Ma	Location *	WS
Category	Supplemental			GPS Latitude/Longitude	
				Start	End
Item	2017 Storm Damage			38.266686 °	38.265917 °
				-121.528128 °	-121.527194 °
DWR ID	LMA-177

Comment Code					
Inspector Comment					
Levee Evaluation Comments					
Description: District Station 316+24 to 320+12, Sec. 22, T. 5 N. R. 4 E., M.D.M. Approximately 388 linear-feet of erosion exists along the waterside slope of the Sacramento River. The erosion commences approximately halfway down the slope and extends into the rip rap. Some existing rip rap has been pulled off in this section.					
Site ID No: 350					
Site Designation: LMA-177					
Repair Type: Erosion					
Rating: Area of Concern					
Field Date: 7/14/2017					
Notes: Crown is paved road. Erosion scarps between 1-6 ft deep. Area of concern because the deeper erosion only extended for a short distance.

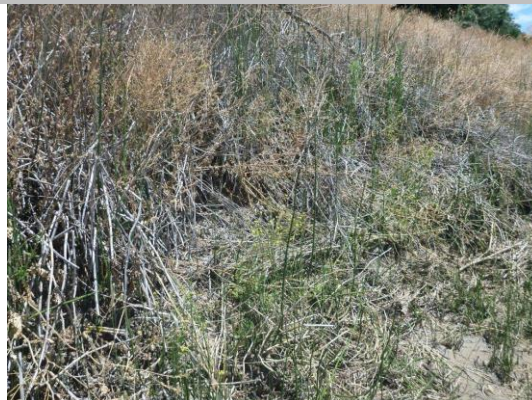
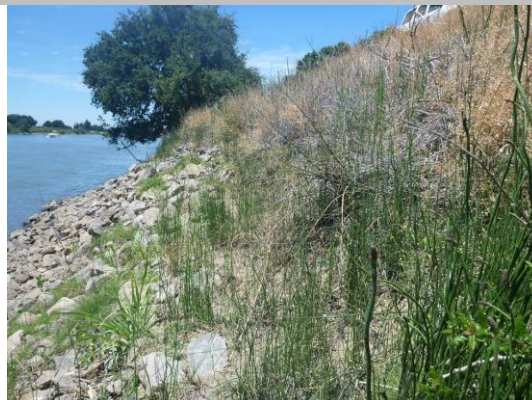
LM Start	6.22	Rating **	A/W	Issue No.	42 (cont)
LM End	6.24	Issue Type +	Ma	Location *	WS
Category	Supplemental			GPS Latitude/Longitude	
				Start	End
Item	2017 Storm Damage			38.264436 °	38.264233 °
				-121.525472 °	-121.525219 °
DWR ID	LMA-178

Notes: Crown is a paved road. Scarps above rip rap are about 7 ft deep. Rated this serious because erosion scarps are pretty deep, sandy material, steep slope, the rip rap is in poor condition and high traffic on the levee road.

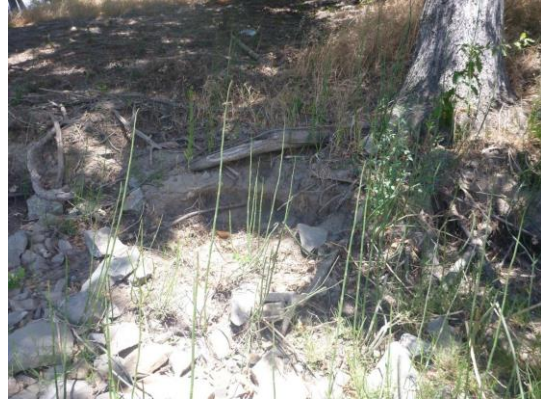
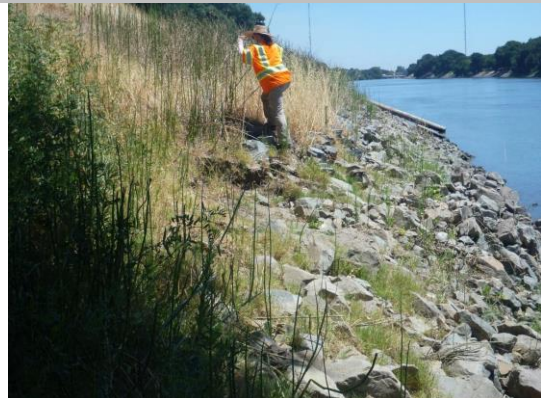
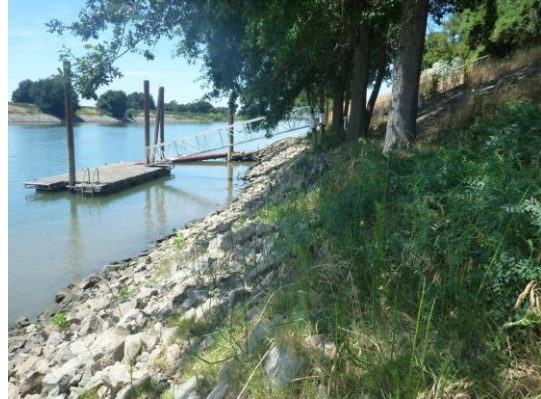
LM Start	6.27	Rating **	A/W	Issue No.	43
LM End	6.29	Issue Type +	Ma	Location *	WS
Category	Supplemental			GPS Latitude/Longitude	
				Start	End
Item	2017 Storm Damage			38.263906 °	38.263756 °
				-121.524778 °	-121.524575 °
DWR ID	LMA-179
